C6 2005-2013 -Automatic Transmission - Stuck in Neutral or Drive or won't shift out of Park.

## **How to Release Auto Shifter Stuck in Park or Unable to Get back to Park**

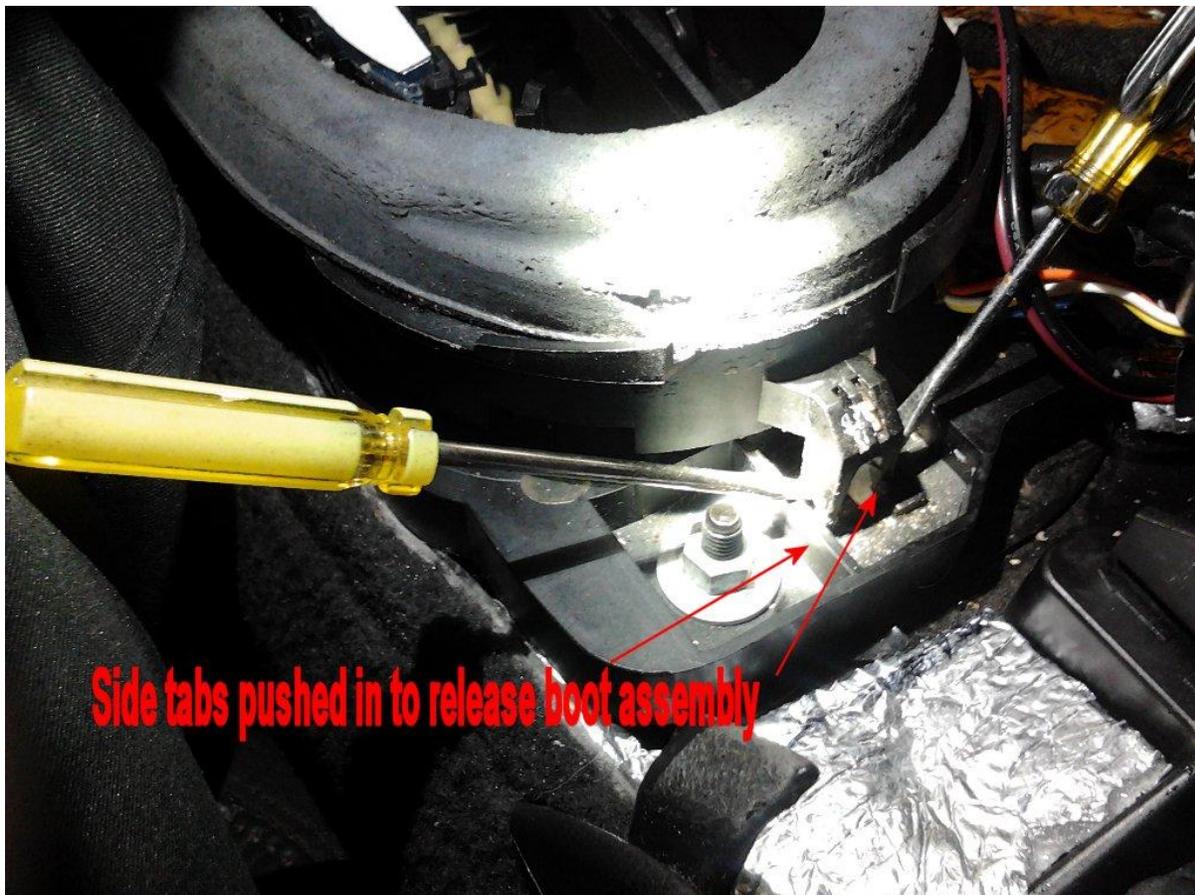
- 5) To remove this top section, which is held in place by (2) plastic locking tabs that fit in a square hole. There is one on the dash side (top) and one on the console side (bottom).

- 6) As per the above picture, with 2 small flat head screwdrivers, start with the bottom, and wedge a screwdriver on each side of the locking tab, prying the tab inwards until the tabs release and the section can be lifted up and out. Use the same technique for the top tab. The above picture only shows the bottom locking tab location.
- 7) With the tabs freed up, lift up the top plastic assembly. This will separate the (red) shift position pointer from the shifter position coupler (black piece). This will be returned to the proper position during re-assembly. The picture shows the red pointer and the black coupling that the pointer fits into, located on the shifter shaft over the white plastic.

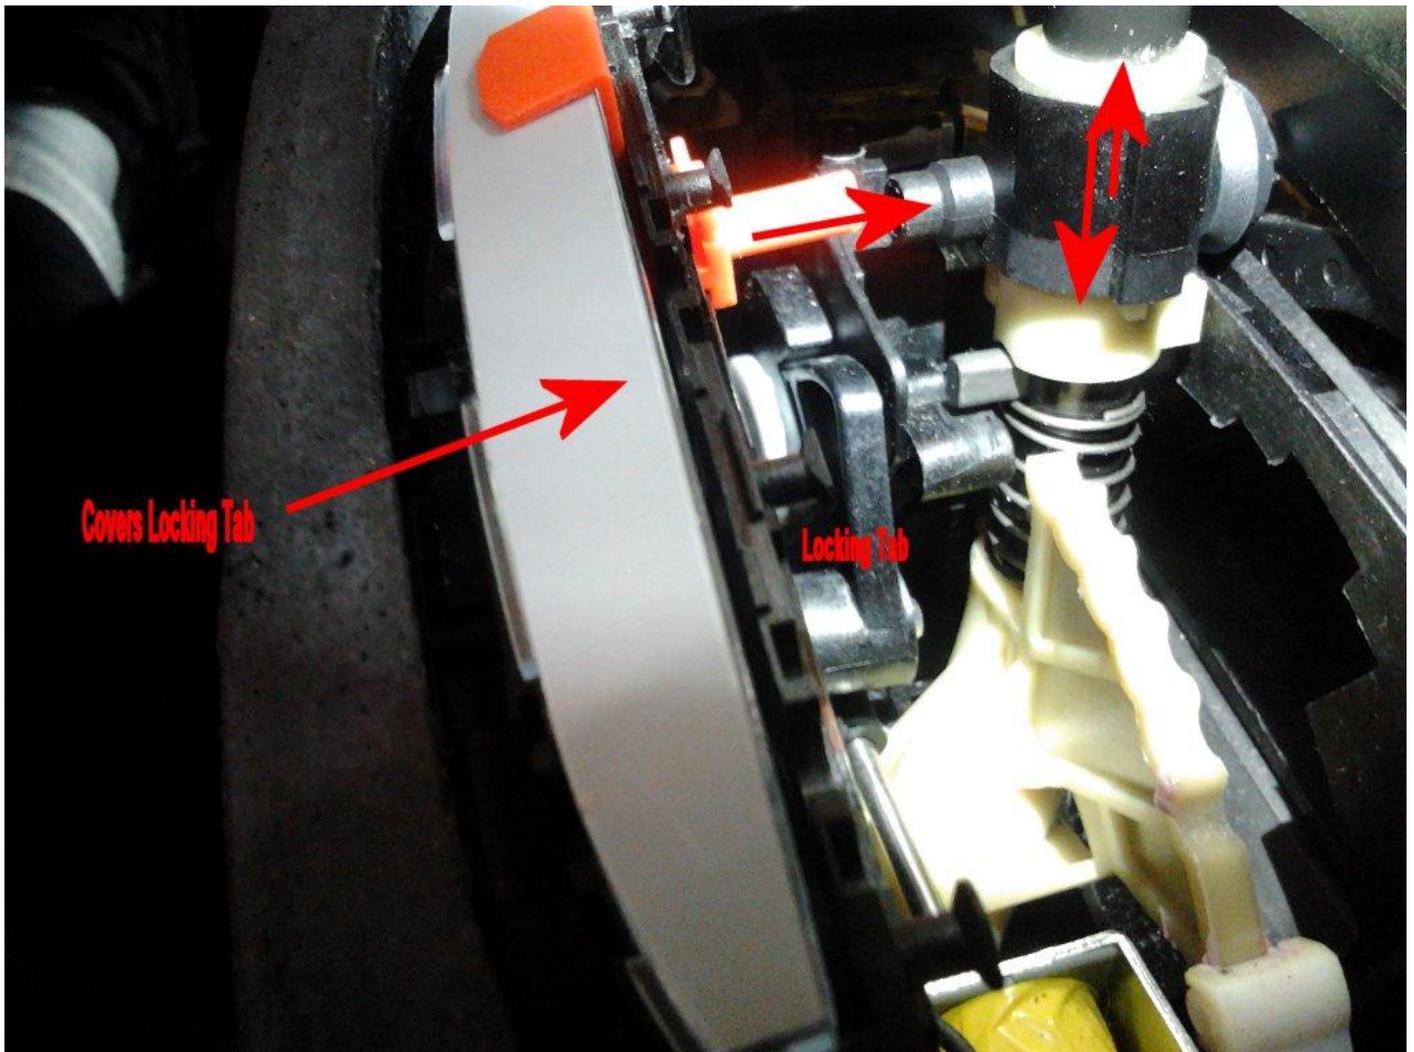
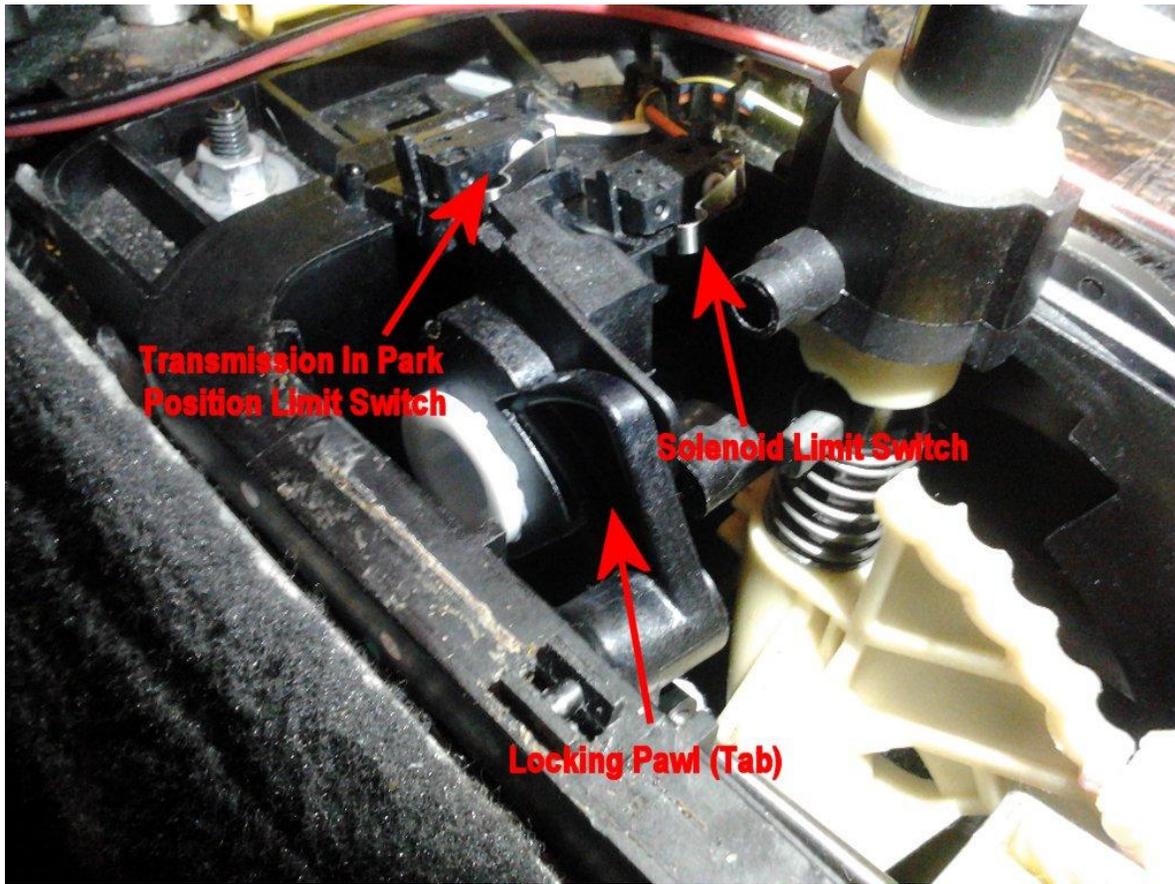
- 8) With the removal of the top section, all the parts that incorporate the shifter mechanism are now in plain view.

The above pics have: the shifter shaft (with black coupling), a solenoid contact limit switch in front of the shifter. This contact limit switch is made when the shifter is in Park. The contact has to be closed in order for the signal to be sent to energize the Transmission Lock Out Solenoid.

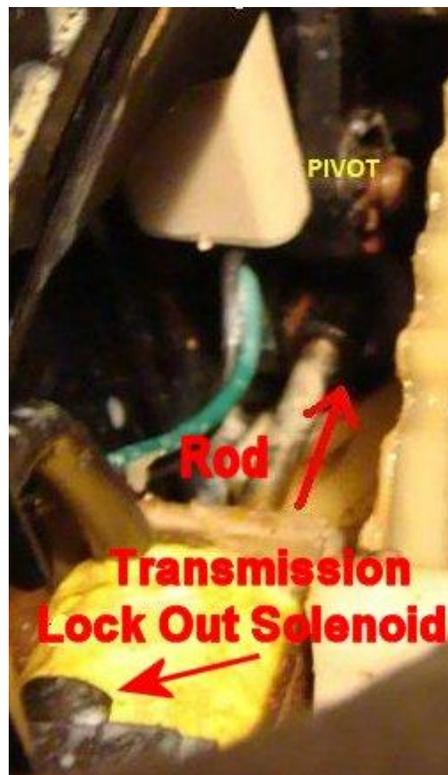
- 9) If the shifter contact limit switch is open, and the Transmission lock out solenoid is not energized, then the shifter will be very stiff to shift out of Park, and will likely not be able to be moved past Drive. For sure, it will be extremely difficult to move back into Park, if not impossible. If the TLO solenoid is not energized, the rod will not move forward to pivot and release the locking pawl (tab).
- 10) The picture below shows a close-up of the Transmission Lock Out Solenoid and rod. When the solenoid is properly energized, it moves the rod forward moving the pivot to release the locking pawl so the shifter button can be depressed and easily moved from Park into gear.

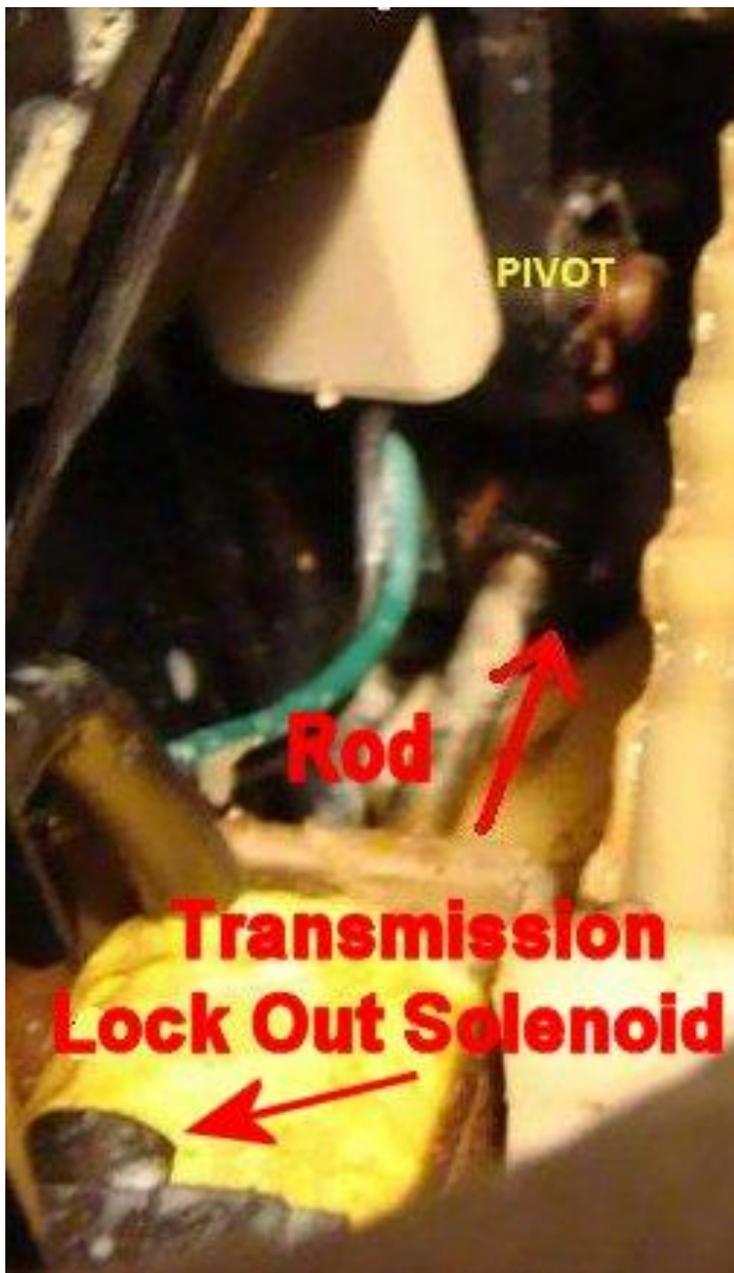
11) The other limit switch located just in front of the locking pawl (tab), is the Transmission In Park limit switch. This must be made for the car to be able to start. The car can also be started if the shifter position is in Neutral.

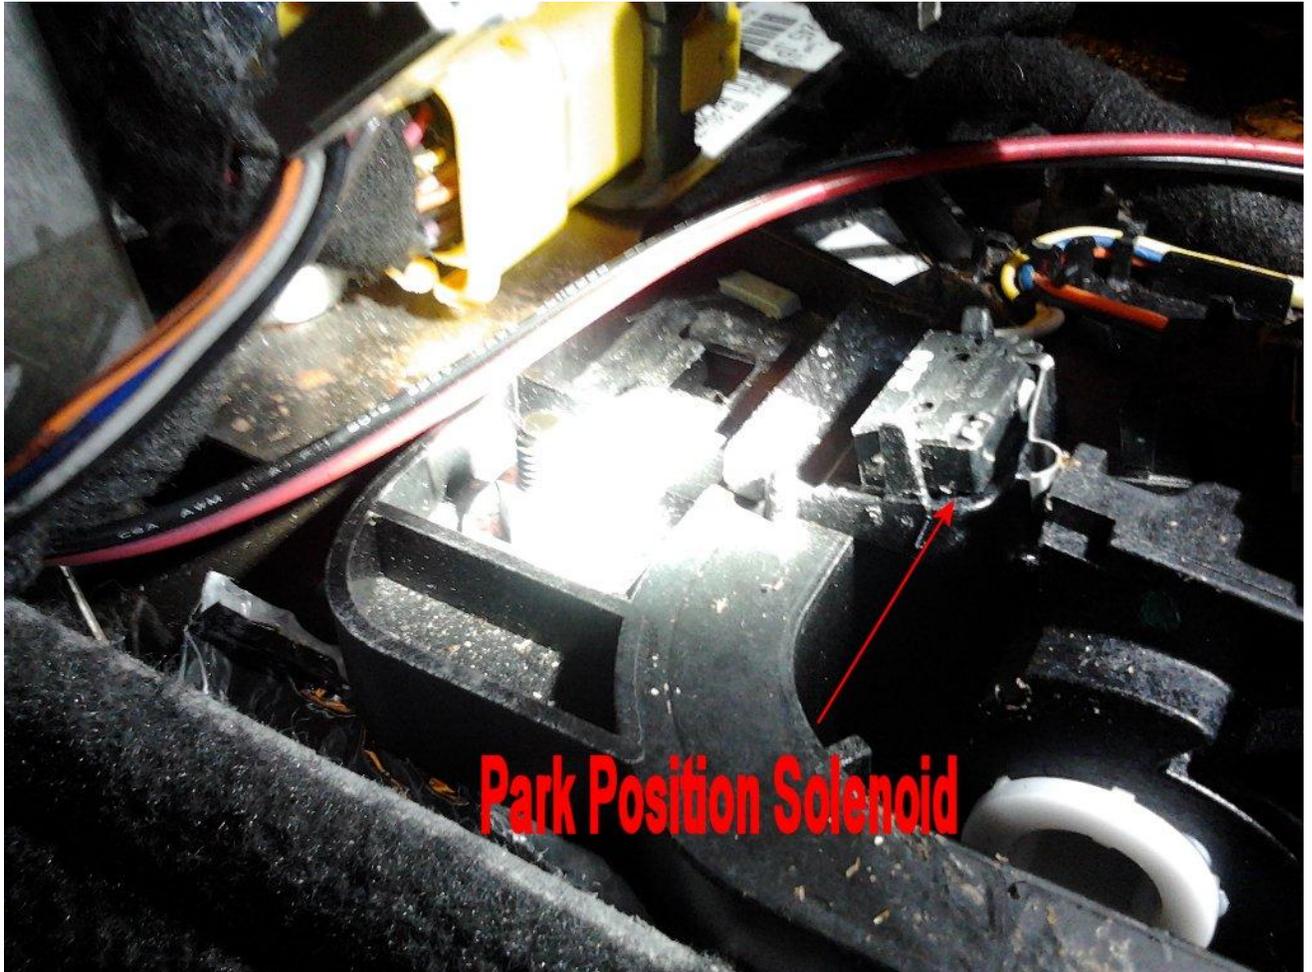
12) Assuming that your transmission is out of Park and stuck somewhere around Drive or Neutral. In order to release the Locking Pawl (tab), a small flat screwdriver can be inserted between the locking pawl and the catch, and pried up to get it released. Once this tab is released, then the shifter finger button can be pushed in, and easily moved into the Park position.

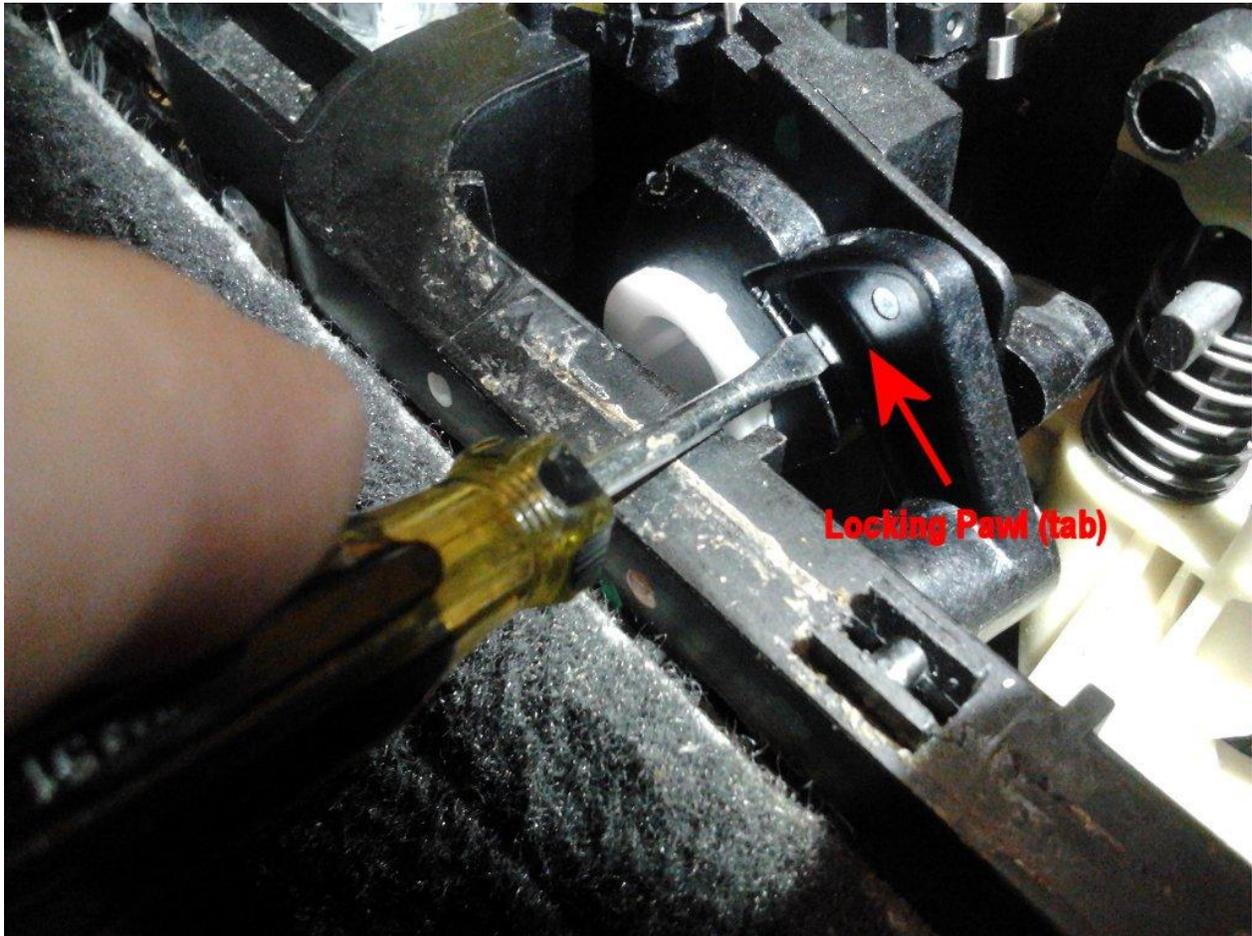
13) The locking pawl (tab) can also be pried and released if the shifter is stuck in Park.

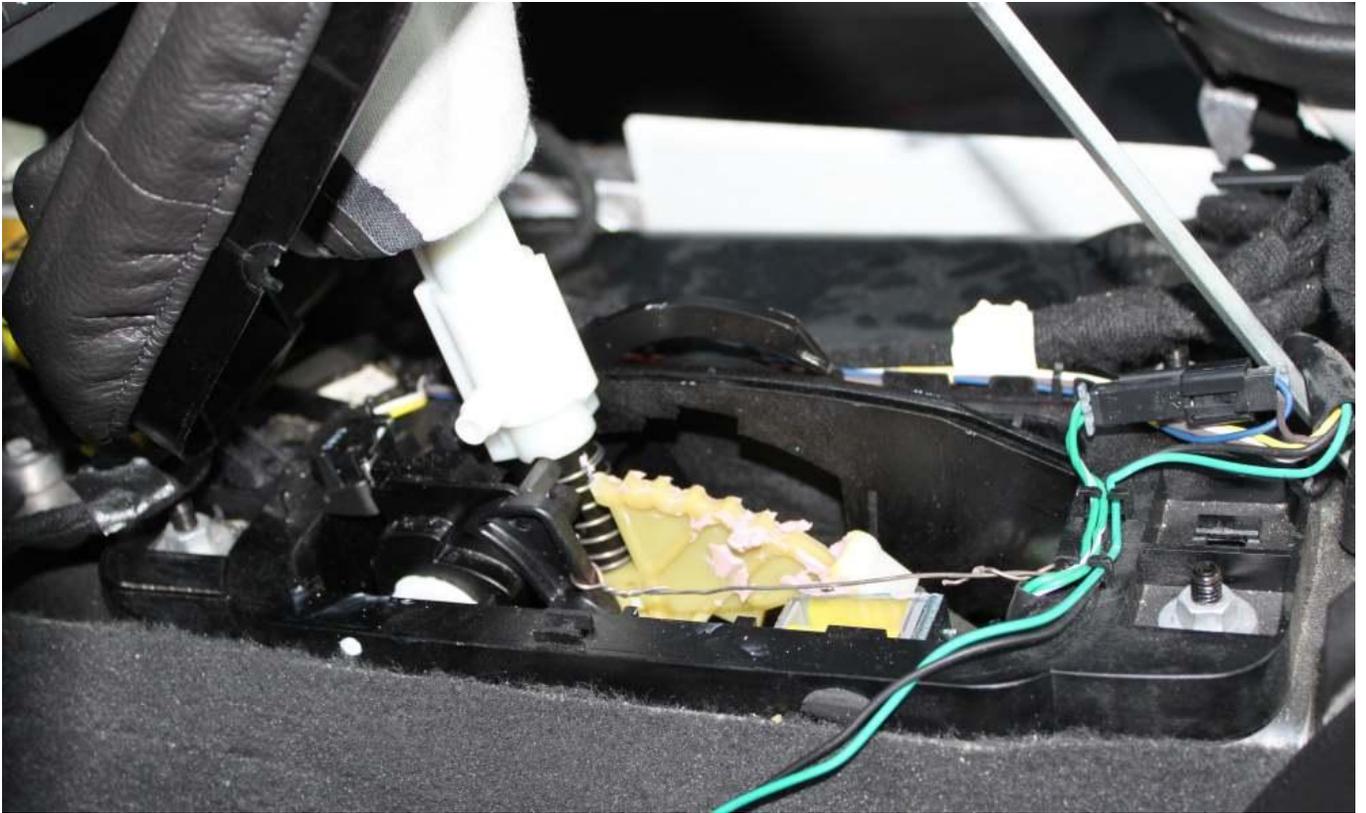
15) In the case of #14, then the locking pawl (tab) can be released, and tied back so it no longer requires the Transmission Lock Out Solenoid to release the shifter, thus eliminating hard shifting or a stuck shifter. See pic to see how to tie back the locking pawl (tab). A small hole will need to be drilled on the side of the pawl to insert a wire.

16) With the locking pawl tied back and taken out of the circuit, there will be no more need to worry about the shifter being hard to shift or stuck in Park.

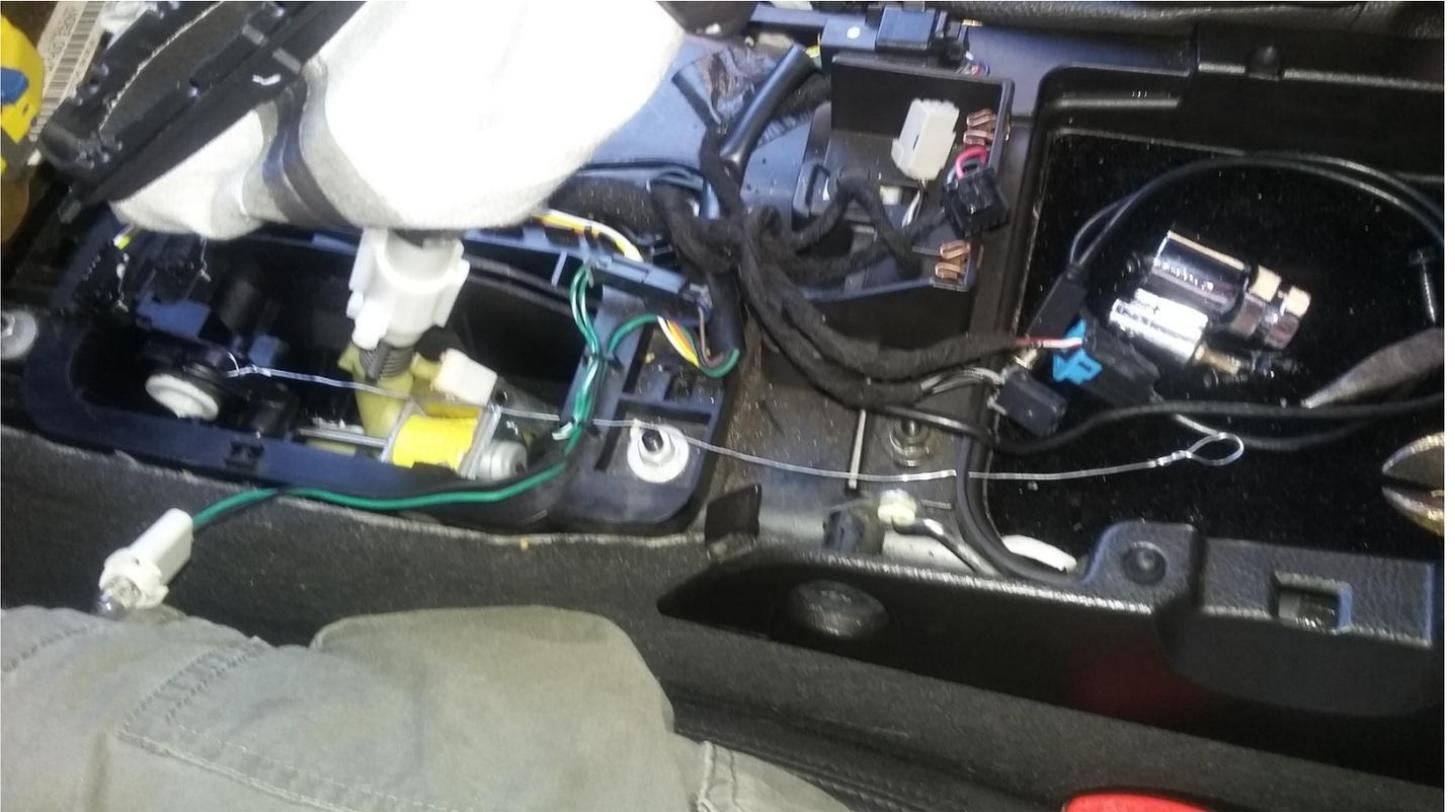
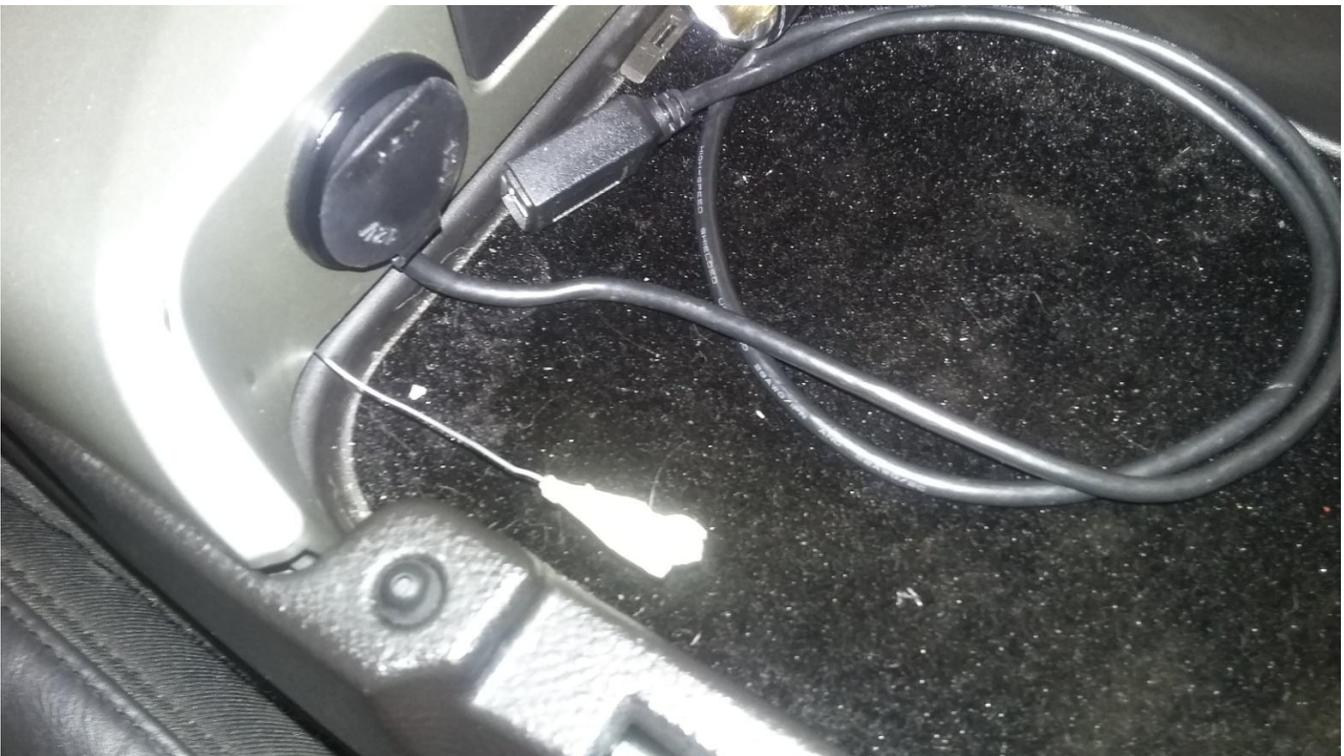
Here is an example pics.

17) Many members tie the pawl, and run the wire to the inside of the console, or on the side of the console so they can release it if the shifter gets stuck. That way, no safety systems are bypassed.
